## Housing Health and Safety Rating System (HHSRS)

## Case Studies

Hazard B11  
Damp and  
Mould Growth

Example B11.1  
1946-79  
End-of-terrace House  
(Non-HMO)

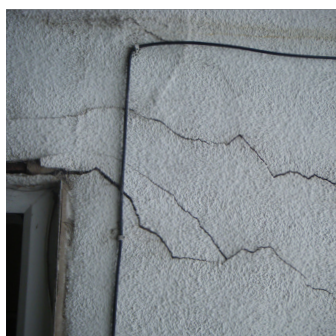
Dampness, caused partly by condensation, affecting the whole of the front external wall surrounding the window and adjacent ceiling and party wall in the small kitchen, however, the location of dampness is consistent with the cracks evident in the external rendering. There are small spots of mould growth, mainly in the corners of the room and at the junctions with the ceiling.

The house does not have an EPC; the family has lived in the property since the 1990s. The roof, gutters and downpipes are in reasonable condition for their age. There is hairline cracking to the external render generally.

2  
External wall with  
cracks to rendering

The baseline indicators adequately address the issue of penetrating damp (by repairing the rendering). The installation of mechanical extract ventilation will assist in reducing condensation, and loft insulation together with upgrades to the heating system to incorporate room thermostat, time clock and thermostatic radiator valves would help to ensure that condensation and mould growth is reduced. Assessment of this dwelling under the related hazard of excess cold would also be useful, to then consider solutions that would have potential to resolve both hazards. Improvements to the heating system and insulation would enable the property to reach the national average (dependant on the works ultimately carried out, they also have the potential to attain better than the national average).

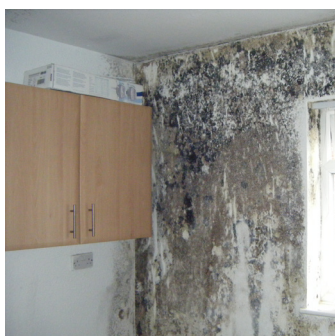
3  
Mould growth to the  
externl kitchen wall

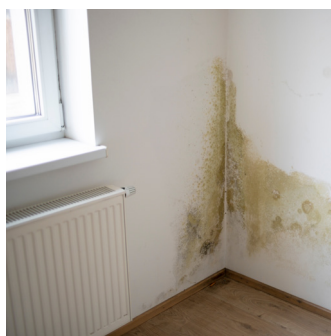
Penetrating damp and some associated mould is affecting the north-facing gable-end wall.

4  
Mould growth to the  
bedroom wall

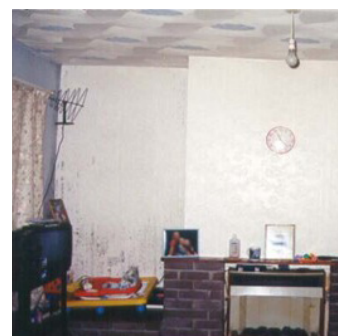
Rising and some penetrating damp with associated tide marks affecting the external gable wall in both recesses to either side of the fireplace in the living room.

5  
Mould growth to the  
living room wall
