## Housing Health and Safety Rating System (HHSRS)

## Case Studies

Hazard A4  
Fire and Explosions

Example A4.6  
Post-1979  
Common parts of  
Residential High-rise

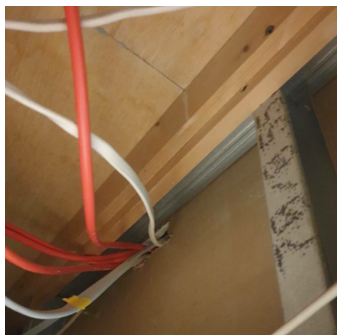
Inadequately fire-stopped service penetrations are present between several service cupboards and routes of escape.

The walls between service cupboards and corridors are constructed with a steel framing system. The steel framing system in some of the cupboards is unprotected from fire on the inner side, which could allow it to fail in the event of a fire, causing it to spread to the means of escape.

6  
Unprotected framing and penetrations to service cupboard

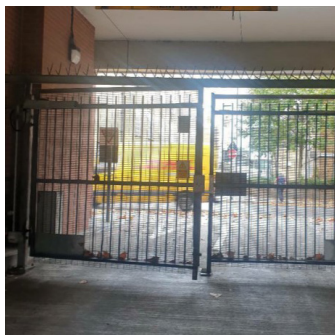
From the car park, exit is through a set of automatic gates. The gates can be overridden to operate as manual gates, but there are no signs informing occupants of how to do this. This route is an unsuitable fire exit and escape route as there is no clear way for escaping occupants to reach an ultimate place of safety.

7  
No signage informing how to manually override car park gates

Compliance with BI 19.7 would require an override function to be installed to the exit door onto the street at the front of the building, so that it can be opened in the event of a loss of local power to the automatic motors. Whilst the gates from the car park can be overridden, signage is needed to instruct how this can be achieved.
