## Housing Health and Safety Rating System (HHSRS)

Hazard B10  
Radiation

Example B10.1  
1946–79  
Mid-terrace House  
(Non-HMO)

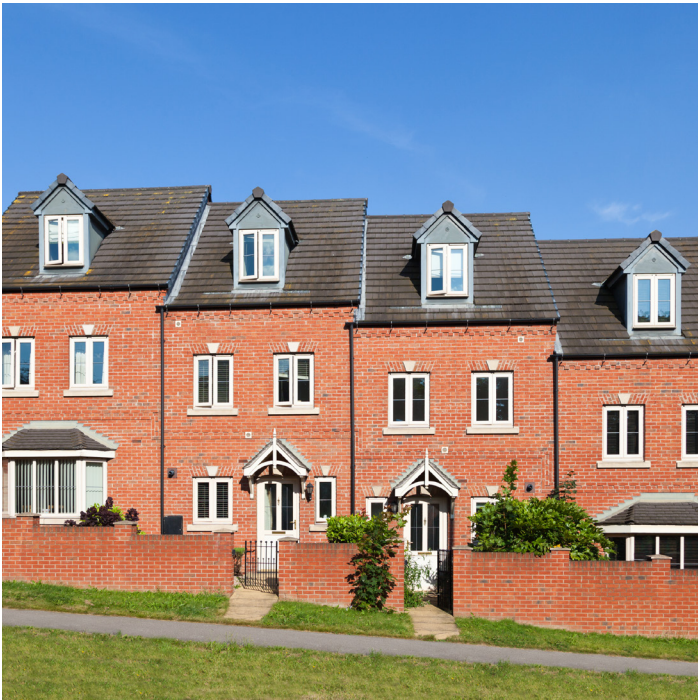
1  
Front elevation of terrace

This is a 1970s mid-terrace house on a steeply sloping site. It has cavity brick walls with retro-fitted insulation. The property is situated in an area of the South West identified on UK Radon.org information maps as having the highest radon potential (greater than 30%). There is mechanical extract ventilation to both the bathroom and the kitchen.

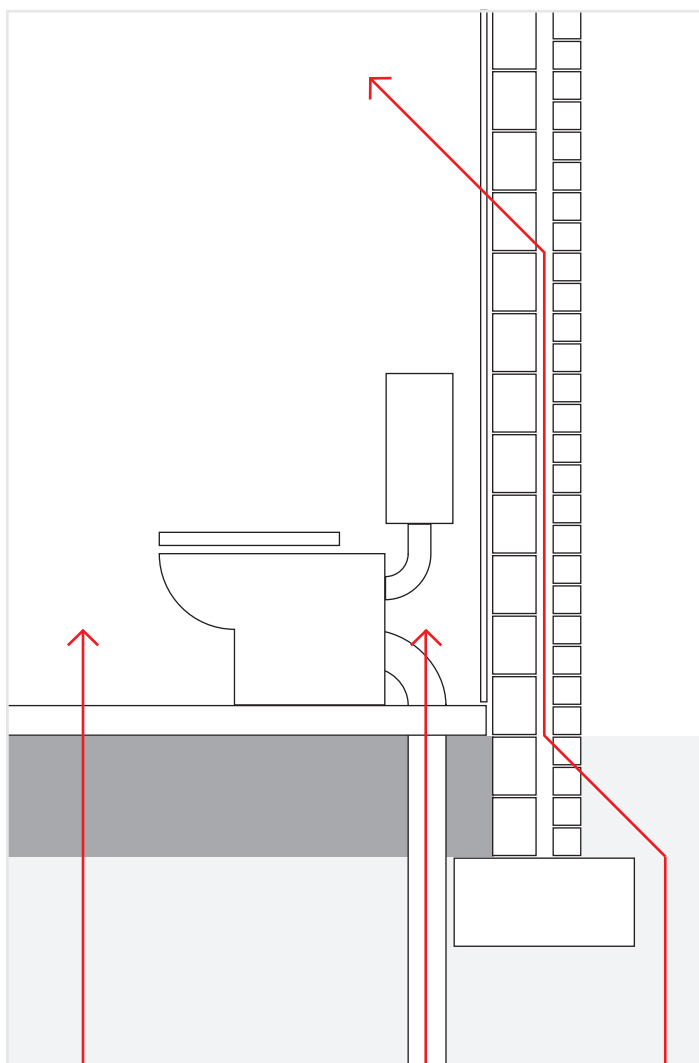
All the houses in the terrace are affected by the gas but to varying degrees, the larger end houses having the highest levels. The house being assessed has the lowest level in the terrace, and with a radon measure of  $196\text{Bq/m}^3$ , it falls just below the radon action level. The other houses in the terrace have levels of 914, 739, 226 and  $2,274\text{Bq/m}^3$ . These measurements were taken during winter months.

All the ground-floor rooms have solid concrete floors in sound condition. Built before radon-protective measures became a requirement of the building regulations, all floors have a damp-proof membrane, but this of an insufficient specification to stop the ingress of radon gas around the joints with the walls and pipes and via the cavity walls.

2  
Ingress of radon gas can occur around the joints with the walls and pipes and via the cavity walls.

This property is located in a terrace where all the houses are affected by radon gas, but this property has the lowest level in the terrace, with a radon measurement of 196Bq/m³. Given the property was built before the requirement to have radon prevention measures in place, the damp-proof membrane that is present provides inadequate protection to prevent the ingress of gas, and there is a risk that over the next 12 months the radon level could increase (given the levels in the other properties). As the measured level approaches the action level of 200Bq/m³, the likelihood has been increased to 1 in 1000.

Works should be undertaken to attain a target level of 100Bq/m<sup>3</sup>. This would change the likelihood to 1 in 2,000. The spread of harms would remain as for the national average. The works are not essential as the current levels do not cause a category 1 hazard, however, they are desirable, as the radon concentration is only marginally below the action level of 200Bq/m<sup>3</sup>. Given the difficulty of excavating all solid ground floors and re-laying with enhanced radon-proof barriers, other options might involve radon sumps being fitted under the ground floor which are continuously ventilated to the outside air and/or positive pressure ventilation systems incorporating heat recovery, which provide an increased rate of air change to prevent radon gas accumulating.
