Housing Health and  
Safety Rating System  
(HHSRS)

Case Studies

Hazard A7  
Structural Collapse  
and Falling Elements

Example A7.1  
1920–1945  
Semi-detached House  
(Non-HMO)

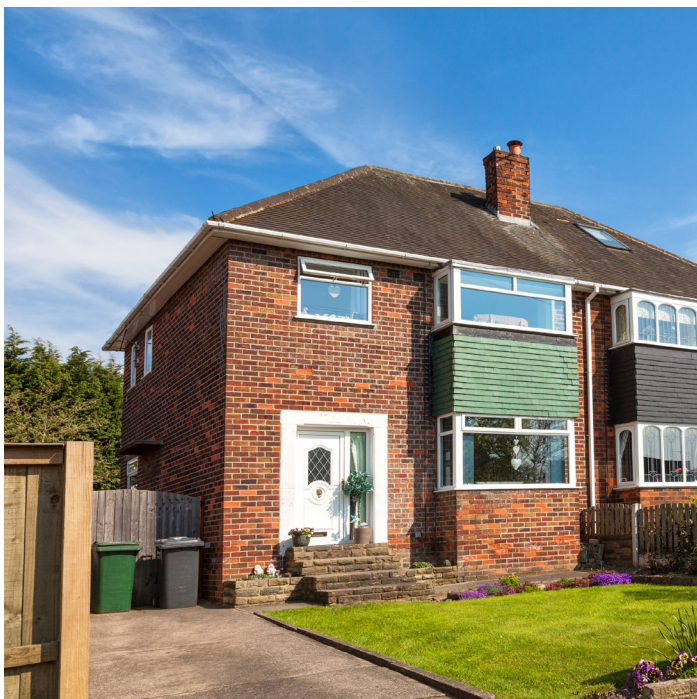
1

Front elevation of property

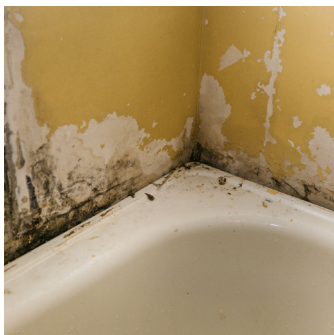
The bathroom is located at the rear of the house, above the kitchen. The mastic seal between the bath and the wall tiles has been crudely applied and it has deteriorated and split, thus not providing a watertight seal. The vinyl floor covering is badly worn and of a poor fit, especially around the toilet and wash-hand basin, meaning that any spilt water can find its way onto and through the floorboards to the joists below. Wet rot in the floor below the bath has caused the boards to deteriorate and some of the ends of the floor joists to come away from their bearings. The edge of the bath adjacent to the external wall has already dropped by 3 cm in places, resulting in cracks and bulging to the kitchen ceiling below.

2  
Failed seal around bath

Compliance with the baseline indicators would ensure replacement of the defective kitchen ceiling and full examination of the bathroom floor joists, replacing where required. This, alongside dealing with all problem areas in the bathroom where water is escaping, making sure sealant is properly applied at all relevant junctions and providing a replacement water-resistant bathroom floor covering, would effectively deal with the defect.

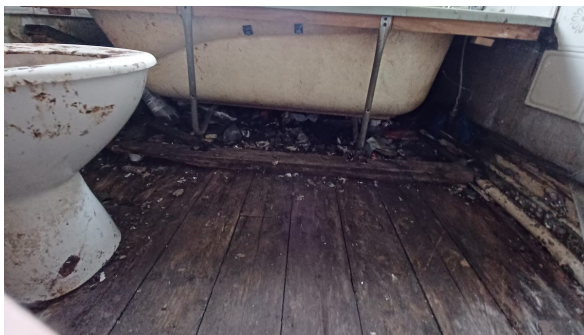
3  
Wet rot below bath

Unless repaired, the escape of water from the bath will continue and further soak the supporting timberwork under the bath, causing continued rotting and failure of the floor materials. As part of the floor has already undergone some movement, the structure beneath is clearly deteriorating and without remedial action will only get worse.

The fact that the joists are compromised as a result of deterioration of the timber, there has already been movement to the floor, and the ceiling beneath is bulging would all suggest that collapse within the next 12 months would be very likely, with probable risk of injury.

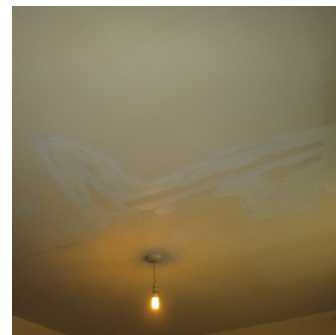
4  
Water ingress and bulge  
to kitchen ceiling

The location of the bathroom – being directly above the kitchen and its specific areas that are in regular use – dramatically increases the likelihood that, in the event of a collapse, someone at ground-floor level will be affected.

A collapse of the kitchen ceiling would likely occur onto the wall-mounted units in the first instance. However, if an occupant were to be in the immediate vicinity, then the units and any ceiling debris could fall onto that person. 'Severe' and 'Serious' harms have consequently been slightly increased beyond the national average score.
