## Housing Health and Safety Rating System (HHSRS)

## Case Studies

Hazard  
Damp and  
Mould Growth

Example  
1946–79  
First-floor Flat  
(Non-HMO)

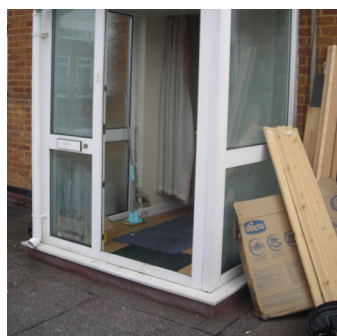
There is some mould growth on the window reveals in the bathroom and, to a lesser extent, in the kitchen and bedrooms. Moisture from condensation was pooling in the porch at the time of the inspection, which was on day when the external temperature was 0°C.

3  
Entrance porch and  
flat roof exterior

Extending the heating system to the porch and hallway would further help to reduce the likelihood of an occurrence.

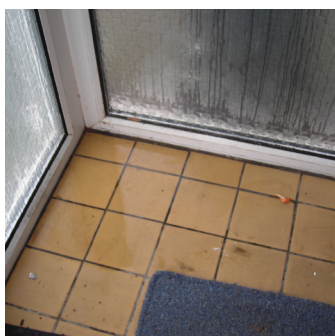
4  
Pooling water on porch  
floor interior

The baseline indicators require mechanical extract ventilation to be fitted to the kitchen and bathroom, and the kitchen airbrick to be unblocked. If the extract ventilation from the kitchen and bathroom is effective, condensation and further mould growth should be eliminated. Provision of improved insulation to the flat roof combined with cavity wall insulation and a more efficient controllable heating system should allow the surface temperatures of the walls and ceilings to be kept well above the dew point.

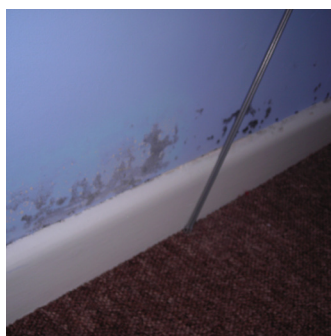
There is black mould growth above the skirting boards due to condensation on the rear external walls and at the junctions with the ceilings in both bedrooms.

5  
Mould growth in  
smallest bedroom

The poorly insulated flat roof and lack of cavity wall insulation are leading to excessive heat loss. Cold external walls and ceilings result in condensation and associated mould growth. Lack of extractor fans in kitchen and bathroom together with the ventilation issues associated with the blocked airbrick in the kitchen exacerbates the condensation problem. Occupants may be reluctant to leave windows open due to security concerns as these windows are easily accessible from the flat roof. Lack of heating in the entrance hallway combined with lack of timer and thermostatic controls to the storage heaters make the heating system less effective and more costly to run. Black mould growth in both bedrooms, kitchen and bathroom will result in exposure to mould spores, which can trigger allergic symptoms and cause asthma. Whilst mould growth is affecting a relatively small area in each room, it will increase the likelihood of harm.
