## Housing Health and Safety Rating System (HHSRS)

Hazard A3  
Falling Between  
Levels

Example A3.5  
Post-1979  
Detached House  
(Non-HMO)

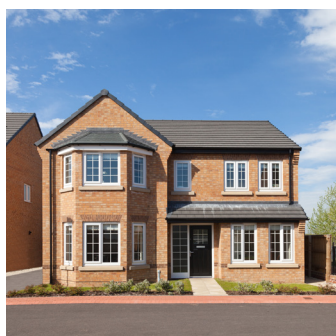
1

Front exterior

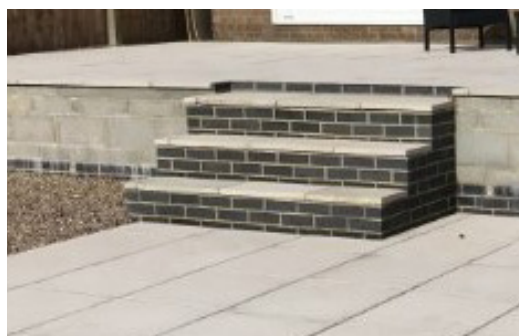
There is a raised patio area of smooth concrete flagstones across the whole of the rear of the house, with a further lower level of flagstones below. The garden slopes gently across the width of the site so there is a drop of 700mm onto a gravelled area at one side, increasing to an 860mm drop onto concrete flagstones at the other side. There is no guard rail or barrier at the edge of the raised patio. When viewed from the house, the change in level between the two levels of concrete flagstones is not immediately apparent. There are no exterior lights at the rear of the property.

2  
Rear garden showing  
changes of levels

Lack of demarcation along the edge of the raised patio combined with absence of any guarding or handrail increases, over the course of a year, the likelihood of a fall causing injuries that require medical intervention. Absence of external lighting also adds to the risk of falls occurring.

Young children lack situational awareness and could jump, walk off, crawl over or fall from the raised patio when playing in the garden. Whilst they are less likely to sustain an injury when falling the shorter distance onto gravel, a fall at the higher end onto concrete slabs, or a fall onto the hard edges on the brick-faced steps could result in bruising, fractured bones or a head injury/ concussion.

Although the height is by no means excessive (compared to falls from a window, for example), falling head first onto concrete would be more likely to cause severe, and serious harms such as major fractures or concussion, thus resulting in the score being higher than the national average.

Baseline indicators would require the installation of suitable guarding, between 900 and 1100mm high along the edge of the raised patio, except for immediately in front of the steps. The guard should be capable of supporting normally imposed loads and designed to avoid gaps greater than 100mm, with no climbable cross-pieces. A solid structural glass balustrade could be installed if the owner wanted to retain a clear view over the garden.

Baseline indicators would also require the installation of external sensor lighting capable of illuminating the raised patio and step area after dark. These measures combined would return the likelihood and harm outcomes to the national average.
