# B9.5/B11.5

## Housing Health and Safety Rating System (HHSRS)

Example B9.5/B11.5  
Post-1979  
Mid-terraced House  
(Non-HMO)

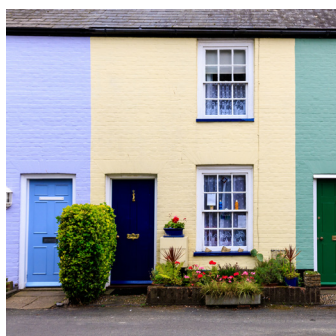
1  
Front exterior view of  
property

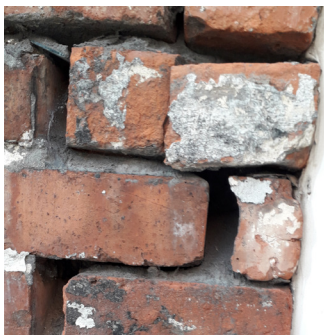
In the unheated rear utility room where the boiler is situated, the single-leaf exterior end wall has patches of perished plaster and flaking paint. Externally the rear wall requires some repointing. A number of bricks are perished and there are open mortar joints (the affected area is 5m<sup>2</sup>, which is the majority of the rear wall).

4  
Damaged brickwork

Compliance with the baseline indicators relevant to Excess Cold would require the replacement of the existing boiler with a modern and more efficient condensing boiler. This would be implemented alongside the installation of a fully controllable modernised heating system, including room thermostat, programmer and thermostatic radiator valves to radiators. The further provision of a minimum of 250 mm loft insulation will assist with retention of heat at a comfortable level. Compliance with the baseline indicators relevant to Damp and Mould Growth would require the installation of mechanical extract ventilation to the kitchen and bathroom, and completion of necessary repairs to the structure of the property to resolve the areas of penetrating damp, leaving a sound, watertight finish.

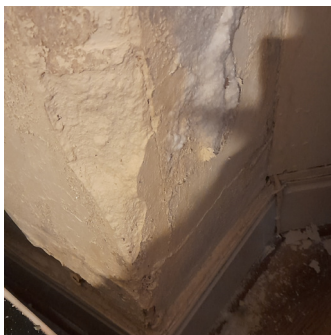
There are small areas of penetrating damp under the bay window in the living room. The brickwork under the bay requires some repointing and there is salt on the surface of the bricks, indicating that the wall does not dry out after heavy rain. Internally there is some mould growth on the wall under the bay window (less than 5% of the wall area of the room) and the plaster is damp to the touch after heavy rain in winter months.

5  
Damp salted  
internal plaster
