## Housing Health and Safety Rating System (HHSRS)

## Case Studies

Hazard B13  
Indoor  
Air Pollutants

Example B13.2  
1920-45  
Single-storey  
House  
(Non-HMO)

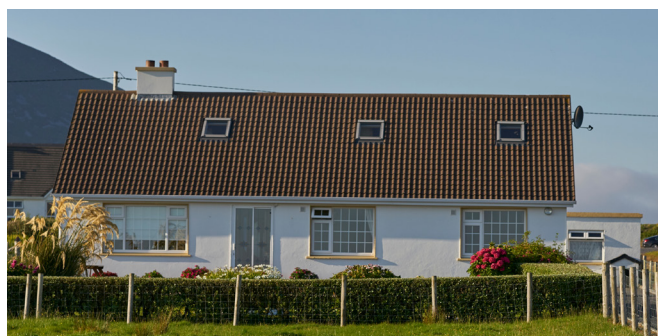
1

Front exterior

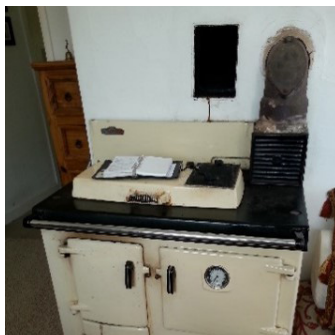
3  
Close up of stove front

There are no instructions for the use of the stove, nor are there any details of the correct material to burn on it, and it doesn't have any servicing records. The use of inappropriate fuels may be less efficient in terms of combustion, leading to increased levels of by-products.

The requirements set out in BIs 15.4 and 15.6 should be implemented, ensuring the solid-fuel appliance is compliant with relevant standards and is properly maintained, and includes the provision of sufficient air flow to the room hosting the appliance and extract ventilation in both kitchen and bathroom. Trickle vents would also be installed in the windows for background ventilation. The occupants will be alerted to any carbon monoxide emissions by the presence of a detector, as required by BI 19.5. These measures will reduce the likelihood of a harmful occurrence significantly and return to the class of harm outcomes to the national averages for the dwelling type and age. The score will not however return to the average as the lack of instruction leaves the occupant vulnerable to sub-optimal use, which has the potential to increase the levels of combustion products and reduce the efficiency of ventilation. There is a lack of lobby between the garage and the living accommodation.

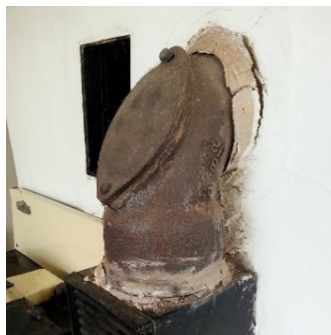
Heating provision for the property is via a solid-fuel stove in the kitchen-diner. The stove has a vertical flue and no cowl, and heats radiators in the bedroom, living room and bathroom. The fire clay around the base of the flue is badly cracked and loose. The flue itself vents into the chimney stack but is in a poor condition, as are the seals around the oven and fire-box doors. There are no instructions for the use of the stove, and the tenant is under the impression it can burn any wood, coal or coke available. There are no airbricks or trickle vents in the windows and no mechanical extract ventilation.

4  
Cracked clay around base  
of flue

The solid-fuel stove, being the heating source for the dwelling, is in constant use for the majority of the year. Unfortunately, this stove has not been maintained sufficiently and is in a state of disrepair. The fire clay around the base of the flue is badly cracked and loose. The flue itself is in poor condition, as are the seals around the oven and fire-box doors. The lack of a cowl to prevent backflow due to weather conditions and the disrepair to the flue means that there is an increased likelihood that combustion by-products will be released into the indoor environment.
