Housing Health and Safety  
Rating System (HHSRS)

Case Studies

Hazard A7  
Structural Collapse  
and Falling Elements

Example A7.3  
Pre-1920  
Flat

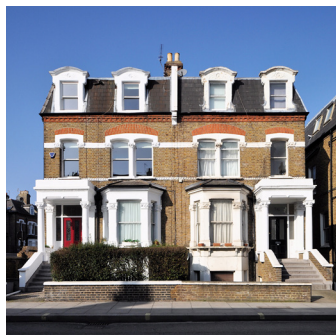
The front façade overlooking the street has been refurbished, including the front roof. The original tall chimneys and pots are in place.

1  
Front exterior

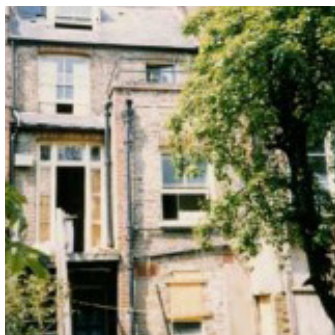
Solid brick walls and original windows are in sound condition, as is the small roof terrace and external stairs and balustrades at the rear.

2  
Communal rear yard:  
stairs to basement flat,  
roof terrace garden

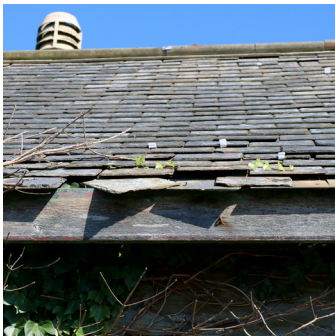
The rear roof is affected by 'nail sickness', with many slipped and some missing slates. The rear eaves gutter is loose. Chimney pots also appear unstable.

3  
Roof with slipped and missing slates

Elements of the building at risk of collapsing or falling include loose slates from the rear roof slope, the pot from the chimney stack and loose eaves guttering, all presenting a risk of harm to occupants. In addition to the risks posed by using the communal areas, in respect of the first-floor flat occupants, there is also risk involved in the use of the private roof terrace at the rear.

An occurrence of falling slates, guttering or chimney pots is most likely during inclement/stormy weather, and during such circumstances, these parts are more likely to fall externally rather than collapse through the roof structure. Although occupants will probably spend less time outside during inclement weather, given the level of disrepair at the rear and slipped slates affected by nail sickness, the likelihood of an incident causing harm over the next 12 months is assessed as likely.

If the baseline indicators were met, the rear roof covering would be repaired/replaced making it sound, safe and watertight, the guttering refixed, and the chimney pots secured. That would effectively deal with the defects, reverting the HHSRS scores to the national averages.

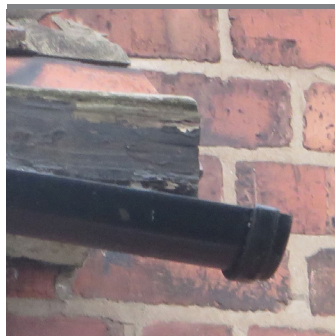
4  
Loose rear eaves gutter

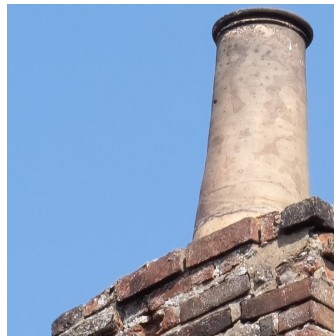
5  
Disrepair to chimney
