## Housing Health and Safety Rating System (HHSRS)

## Case Studies

Hazard A3  
Falling Between  
Levels

Example A3.4  
Post-1979  
First-floor Flat  
(Non-HMO)

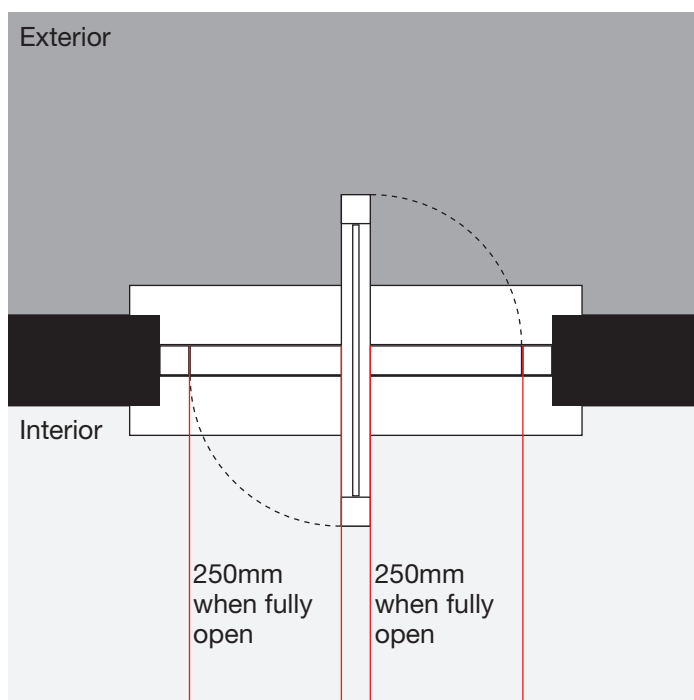
2  
Plan of rotating window detail  
showing opening dimensions

The windows to the flat have a design as shown in the plan above, with a height of around 800 mm above the floor level. There are key locking handles fitted but the keys are missing so they cannot be locked. There are no restrictors fitted to the windows. Below the windows is the hard-surface road at the front of the shops.

Additionally, the window sills are only 800mm above the floor level. The windows do not have restrictors, are of a wide-opening design, and following the loss of the keys, there is no way of locking them. These issues combined mean the windows are easy to access, making falls from them a real possibility.

The baseline indicators would ensure the provision of guarding and external lighting to the flat roof and proper maintenance of the windows, with restrictors and keys for the locks in place. This would mitigate the risk posed by the low sill height. These improvements would significantly reduce the likelihood of a fall occurring, improving the situation to that of the national average. The harm outcomes would however stay the same because they were increased to take into account the external hard surfaces and the distance of the fall: such matters would remain unaddressed by the baseline indicators.

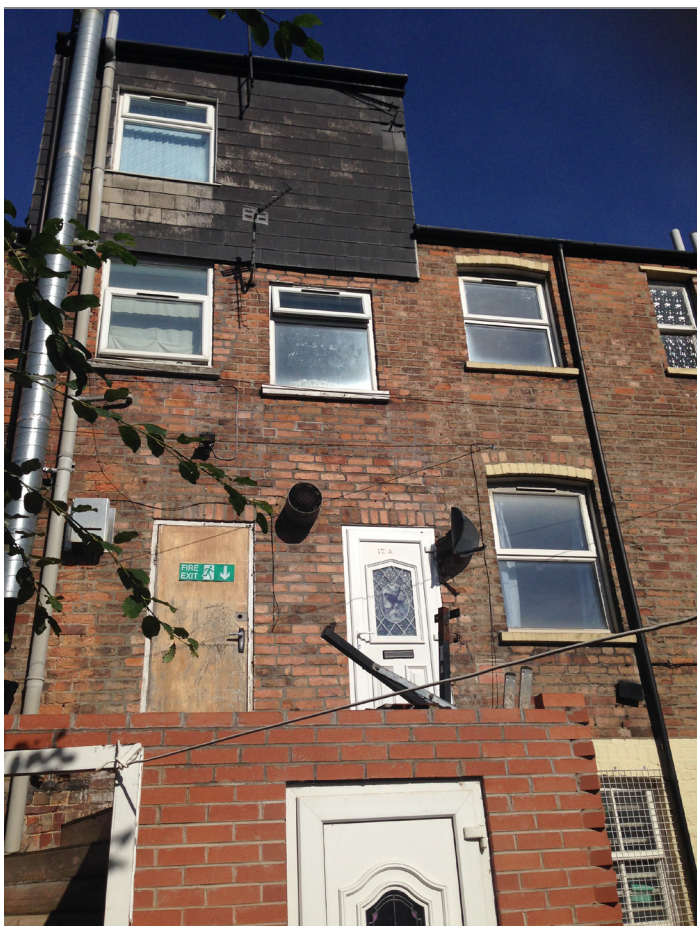
2  
Door onto rear flat roof

The door at the top of the stairwell has a multi-locking mechanism with a thumb-turn lock, as the door is intended to serve as an emergency fire escape. To the left hand edge of the flat roof is a fragile Perspex roof-covering to the supermarket delivery bay (with concrete floor). On the other sides of the flat roof there is concrete below. There is no lighting to this roof, nor is there any street lighting nearby.

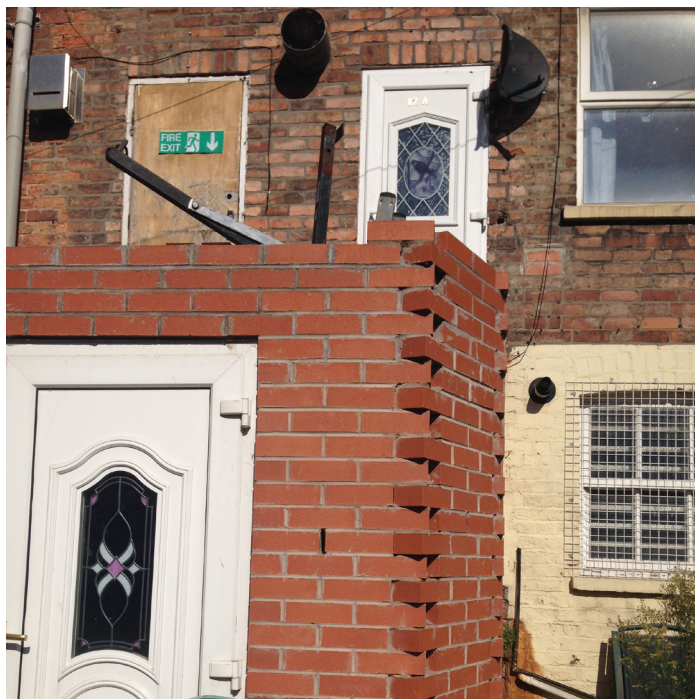
3  
Rear flat roof

The completely unguarded sections of flat roof area and the absence of any artificial lighting source poses a significant risk, especially to those whose sense of risk is less developed (i.e. young children – the vulnerable group for this hazard). This is not the main entrance to the dwelling, so it may not be used on a daily basis; however, the vulnerable group would have to access the flat roof via a door with a thumb-turn lock (no key required). Although the mechanism will be located above the height that an under-5-year-old could easily reach, it remains accessible.

Figures for the 'Extreme', 'Severe' and 'Serious' harm categories have been significantly increased to take into account the hard concrete surfaces onto which the vulnerable group would fall and the lack of any external lighting. These relevant matters significantly increase the harm outcome that would result should an under-5-year-old fall from the roof. The height that they would fall is also relevant.
