## Housing Health and Safety Rating System (HHSRS)

Group C  
Protection Against  
Infection

Example C16.3  
1946–1979  
Semi-detached House  
(Non-HMO)

Hazard C16  
Domestic Hygiene

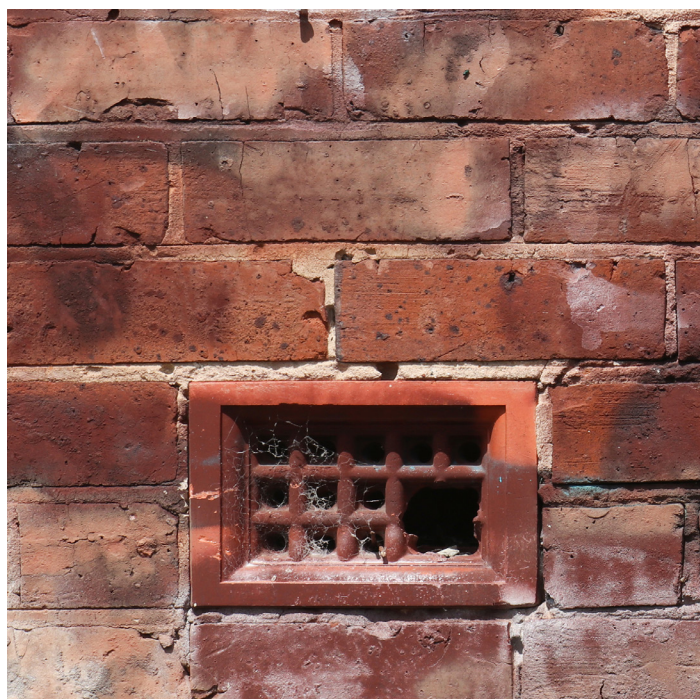
Both of the air bricks at the rear of the property are broken, allowing access to rodents.

3  
One of the broken  
airbricks at rear of the  
property

Compliance with the baseline indicators would see the replacement of the broken covers to the two air bricks to prevent rats and mice gaining access into the cavity walls, along with removal of the old rat droppings and carpet from the loft and disinfection of the area.

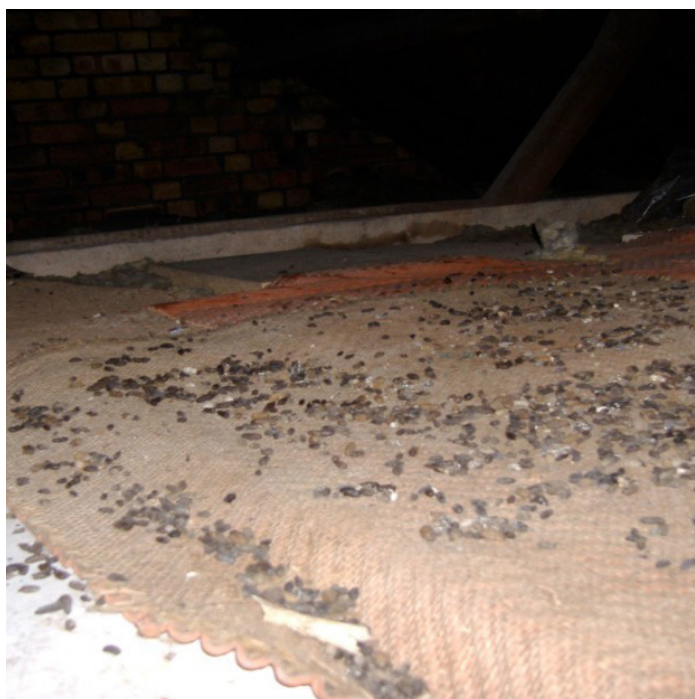
In the roof space, which is not used for storage, carpet has been laid over the existing loft insulation in some areas. There are lots of old rat droppings in the loft, indicating a significant infestation of rats, although there did not appear to be any current rodent activity at the time of inspection.

4  
Droppings in loft space
