## Housing Health and Safety Rating System (HHSRS)

## Case Studies

Hazard B11  
Damp and  
Mould Growth

Example B11.1  
1946-79  
End-of-terrace House  
(Non-HMO)

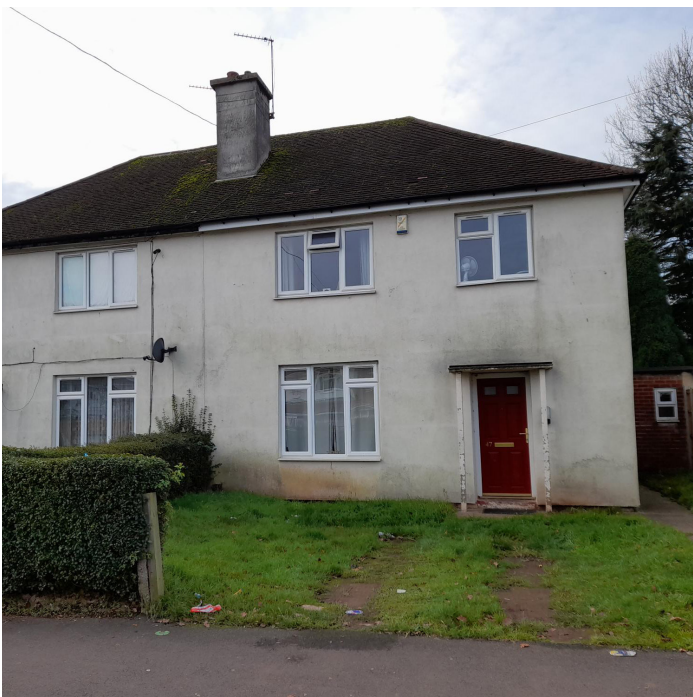
1  
Front exterior of property

Externally the property is in good repair, except on the external gable where there are a couple of cracks. There are no defects to the roof, gutters or downpipes. The house is in a suburban location on a large social housing estate. It is rented to a family of three.
