## Housing Health and Safety Rating System (HHSRS)

## Case Studies

Hazard A2  
Falling on  
Stairs etc.

Example A2.4  
Pre-1920  
Mid-terrace House  
(Non-HMO)

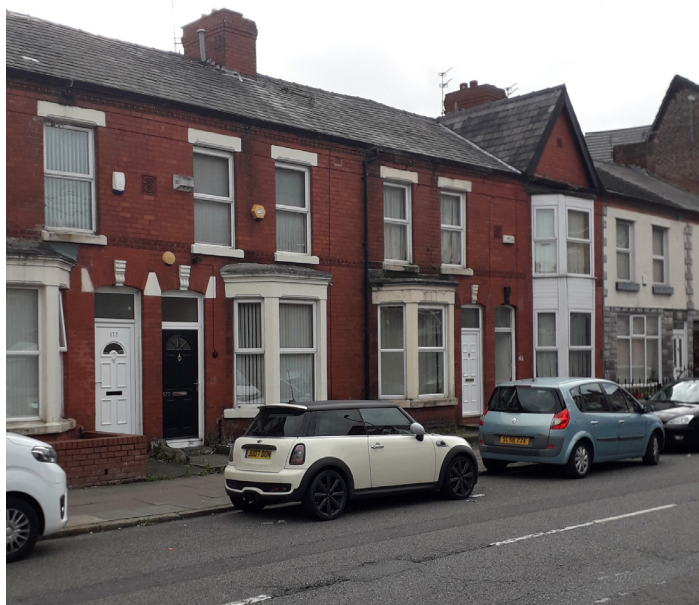
1

This property is a pre-1920, three-bedroomed mid-terraced house. It is in reasonable repair for its age. There are no leaks from the gutters or downpipes. There is no electrical inspection report, the energy performance certificate (EPC) is E, and battery powered smoke alarms have been provided in suitable locations.

The front door is straight off the pavement. There is a shallow step from the back door into a small, well-lit back yard. The house does not have a cellar, and the only toilet is in the upstairs bathroom.

Front view of property

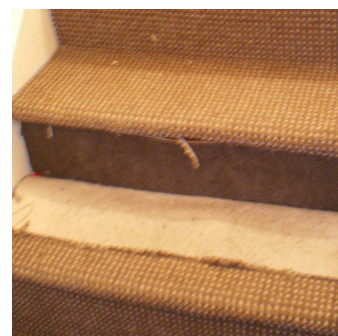
4  
Loose carpet on staircase

The stairs and landing do not have any direct natural lighting, but a two-way light switch to the stairs, top and bottom, is sited in a convenient location. The carpet is loose on the first and second steps up from the bottom.

The BIs would require the loose stair carpet to be secured and a handrail mounted at a height of between 900mm and 1000mm above the stairs, capable of supporting a load of 140kg. The pitch of the stairs remains steep, with a facing wall at the bottom, therefore the likelihood of harm remains slightly higher than the national average for this age and type of property.
