## Housing Health and Safety Rating System (HHSRS)

Group A  
Protection Against  
Accidents

Hazard A1  
Falls on the Level

Example A1.2  
Pre-1920  
Mid-terrace Bungalow  
(Non-HMO)

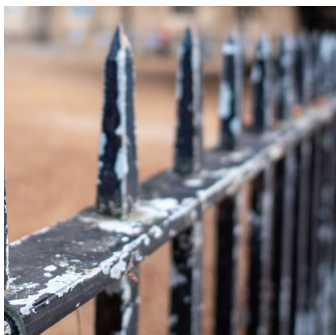
3  
Front yard  
metal railing fence

Access to the front door is via a gate and step, then across the common yard. This has no artificial lighting despite being located on a poorly lit service road. The yard surface comprises uneven stone slabs and brick paving. The spiked iron railings and spiked front gate are about 600mm high.

The risk of extreme, severe and serious harms occurring is increased due to number and location of hard and sharp objects on the property. There are several hard, uneven stone and concrete surfaces in the front and rear yards, with adjacent low-level spiked metal railings. The cooker (with a potentially hot surface) is located just inside the back, opposite a folding worktop.

The risk of harm occurring could be reduced to that of the national average by carrying out the following: removal of the metal spikes to the front; evening out surfaces to front and rear, together with provision of better lighting in both areas; lowering of the threshold to the rear entrance doorway; and improvement to the kitchen layout.

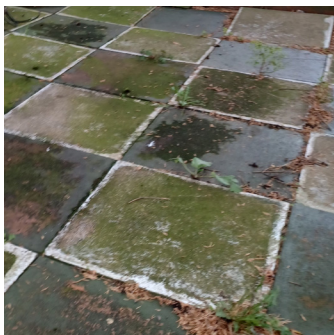
4  
Front yard  
uneven slabs

The risk of falls is increased due to the poorly lit approach to the main entrance across uneven stone slabs. The proximity to spiked metal railings and a spiked metal front gate exacerbates the likelihood of a fall requiring medical intervention. In the kitchen, there is greater risk of someone tripping over the step when coming in from the rear yard and then falling onto the cooker or folding worktop, with associated sharp edges and hot surfaces. Risk of falls in the rear yard is increased due to the cracked and uneven yard surface and restricted lighting. In winter, water pooling in and around the uncovered concrete drainage channel could freeze, leading to slips and falls.
