## Housing Health and Safety Rating System (HHSRS)

Example A6.3  
1920–1945  
Third-floor Flat  
(Non-HMO)

Hazard A6  
Collisions, Entrapment  
and Ergonomics

Related Hazard A3  
Falling Between  
Levels

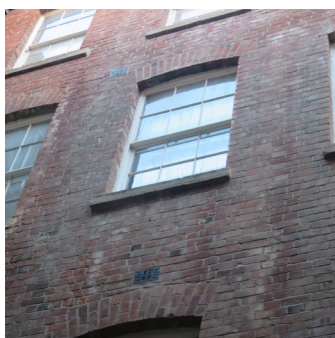
1  
Front view of building

This is a flat in a five-storey, late-Edwardian mansion block that has balcony access at the rear. The living room of this third-floor flat, also located at the rear, still retains its two original vertical-sliding box-sash windows. Both of these have low sills (under 700mm high).

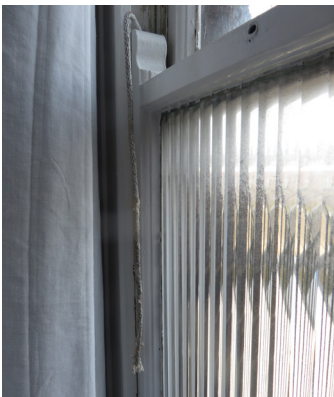
4

Living room windows: In each window, the two large sliding sashes comprise a thin frame, each carrying two large panes of single glazing. All the sash cords are threadbare, and in one window the cord holding one side of the lower opening light has snapped. This window can still be opened and will remain open due to the one remaining counterweight and the friction resulting from the consequent tilting of the frame. In summer, both windows are regularly left open as the living room faces due south and is prone to overheating. The glass is not safety glass, and there is no form of restrictor to the window.

Snapped sash window  
cord

The sash cords supporting the weight of both windows are threadbare and one cord has already snapped, placing increasing strain on the other. With both windows often open due to the south-facing elevation, extra strain will be placed on the remaining sash cords, increasing the likelihood of failure in the next 12 months. If other sash cords fail, the heavy windows would drop suddenly, potentially trapping hands or fingers and causing fractured bones, crushing or severe bruising. The glass could also shatter, causing lacerations. The low sill-height increases the risk of harm to a young child as they could reach through the open window more easily, and would therefore be more likely to have a propped window fall onto them.

If the large sash windows were to fail when wide open, they could fall a considerable distance, causing more serious fractures or crushing injuries. The fall of a window is likely to result in breakage of glass, increasing the possibility of greater than average 'Severe' and 'Serious' harms from cuts as well as trapping.

National average for likelihood and spread of harms following works to comply with baseline indicators. Compliance with baseline indicators should leave the sash windows in good working order with a restrictor to prevent the sash window being opened more than 100mm without positive action to disengage the restrictor.
