## Housing Health and Safety Rating System (HHSRS)

## Case Studies

Hazard A4  
Fire and Explosions

Example A4.9  
Post-1979  
House

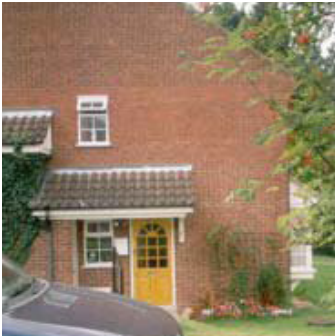
1  
Front elevation

This is a one bedroomed ‘cluster’ house, built in the 1980s and currently rented to a couple. The ground floor has an open-plan kitchen/dining/living room with stairs to a mezzanine floor, where a partition wall has been built to provide privacy to the bedroom.

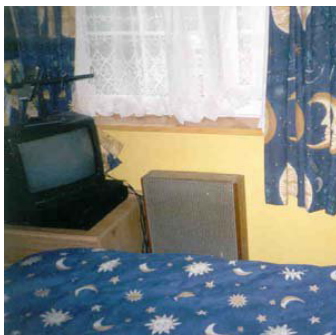
3  
Gas heater in bedroom

A gas convector fire is situated and vented directly under the bedroom window such that the curtains drape over the fire. The small shape and size of the room and door position make it difficult to position the furniture (a double bed, small wardrobe, chest of drawers and bedside tables) in such a way so as to keep the bedding a safe distance from the fire.

There is a gas convector fire in the open-plan ground floor; this is more appropriately located. These gas convector fires date back to the 1970s and do not comply with the current gas safety regulations.

There is no gas safety certificate.

A gas safety inspection should reveal that the convector heater in the bedroom does not comply with current gas safety regulations (as a result of the potential for fumes to vent back into the room if the window is open, for example). An alternative method of heating would have to be provided as it would not be economical to relocate the heater and make it compliant with the gas safety regulations.
